Volume XVIII Number 2 Fall – Winter 2013

Tempest at Tymochtee

One of the AC&Y's worst-ever derailments!

By Bob Lucas

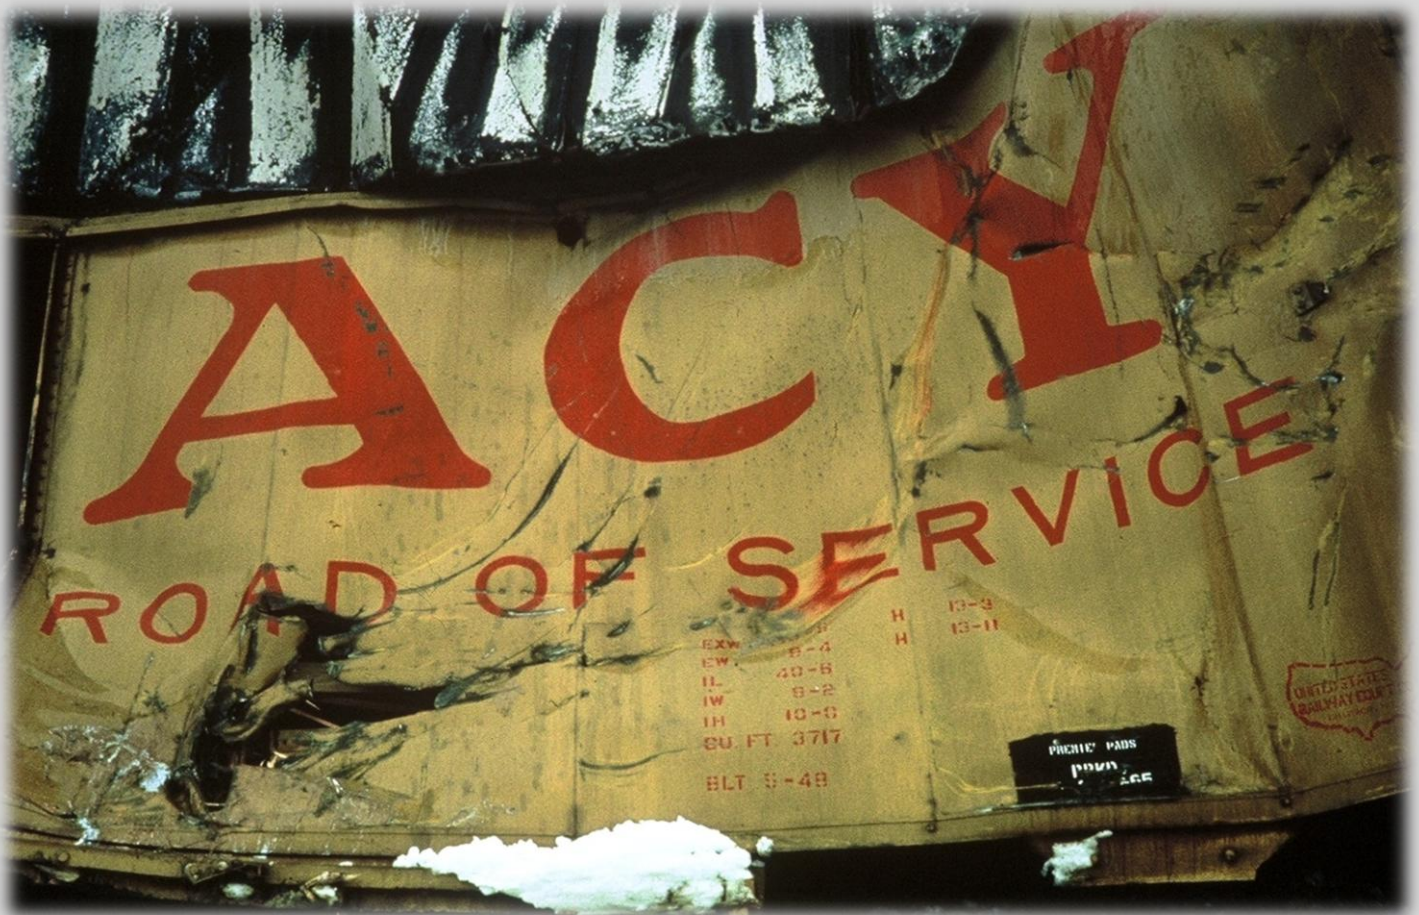
Front cover: On February 4, 1966, the AC&Y endured a major train derailment at Tymochtee, east of Carey. The crumpled side of PS-1 box No. 3308 is evidence of the wreck's intensity. Jim Robert's photo, Author's collection

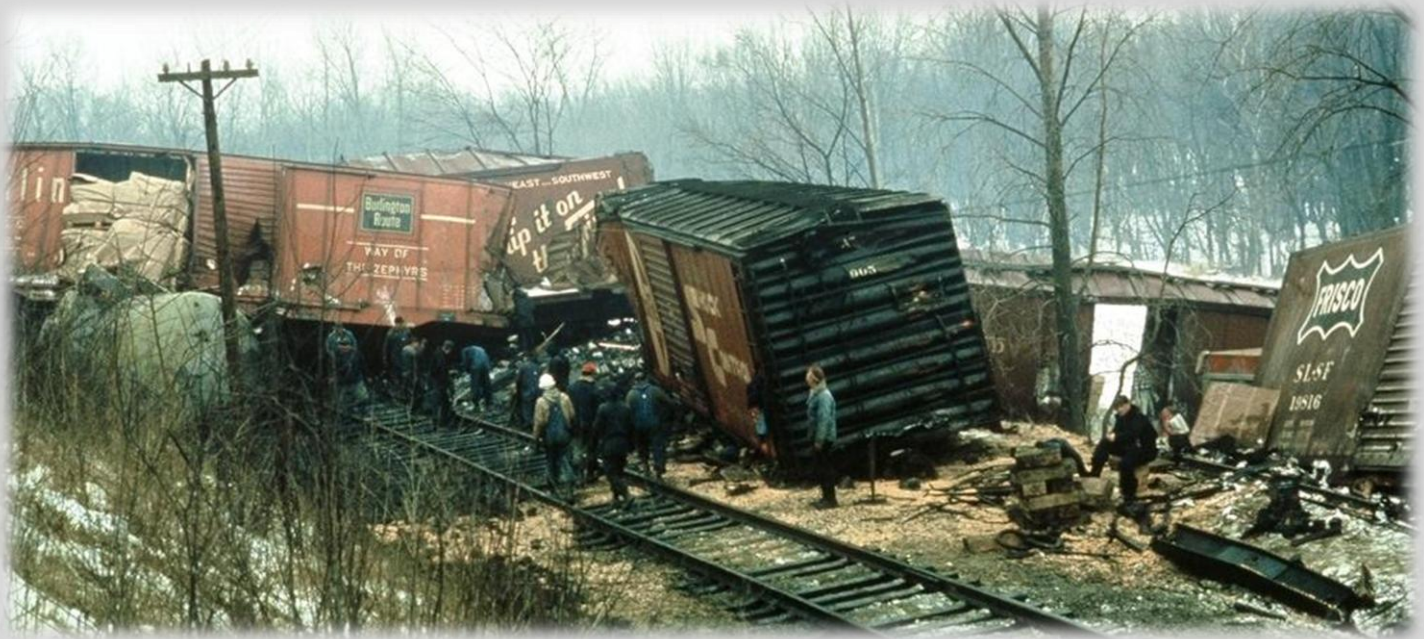
Above: Supervisory personnel, relief workers and by-standers survey the horrific AC&Y derailment that occurred February 4, 1966 at Tymochtee, six-miles east of Carey. Measured by equipment destroyed and financial loss, it was one of the greatest misfortunes ever experienced by the AC&Y. Jim Roberts' photo, author's collection.

The worst derailment occurred 2:40 a.m. on February 4, 1966 at milepost 61 near Tymochtee. Eastbound train No. 94, with F-M diesels Nos. 502-208 departed Carey with 66 cars and 4458 tons. As the train was approaching the Sandusky River Bridge, six miles east of Carey, a rail broke at the apex of a 5½-degree curve, derailing the rear wheels on engine 502, all the wheels on 208 and the 27 cars following.

Examination of the broken rail indicated a fissure in the web of the rail with 33-inches begin broken out from the initial impact, followed by two other pieces of approximately 36-inches each. Ironically, it was comparatively new rail – rolled in 1964 – laid in December, 1964 and was the high rail of the curve.

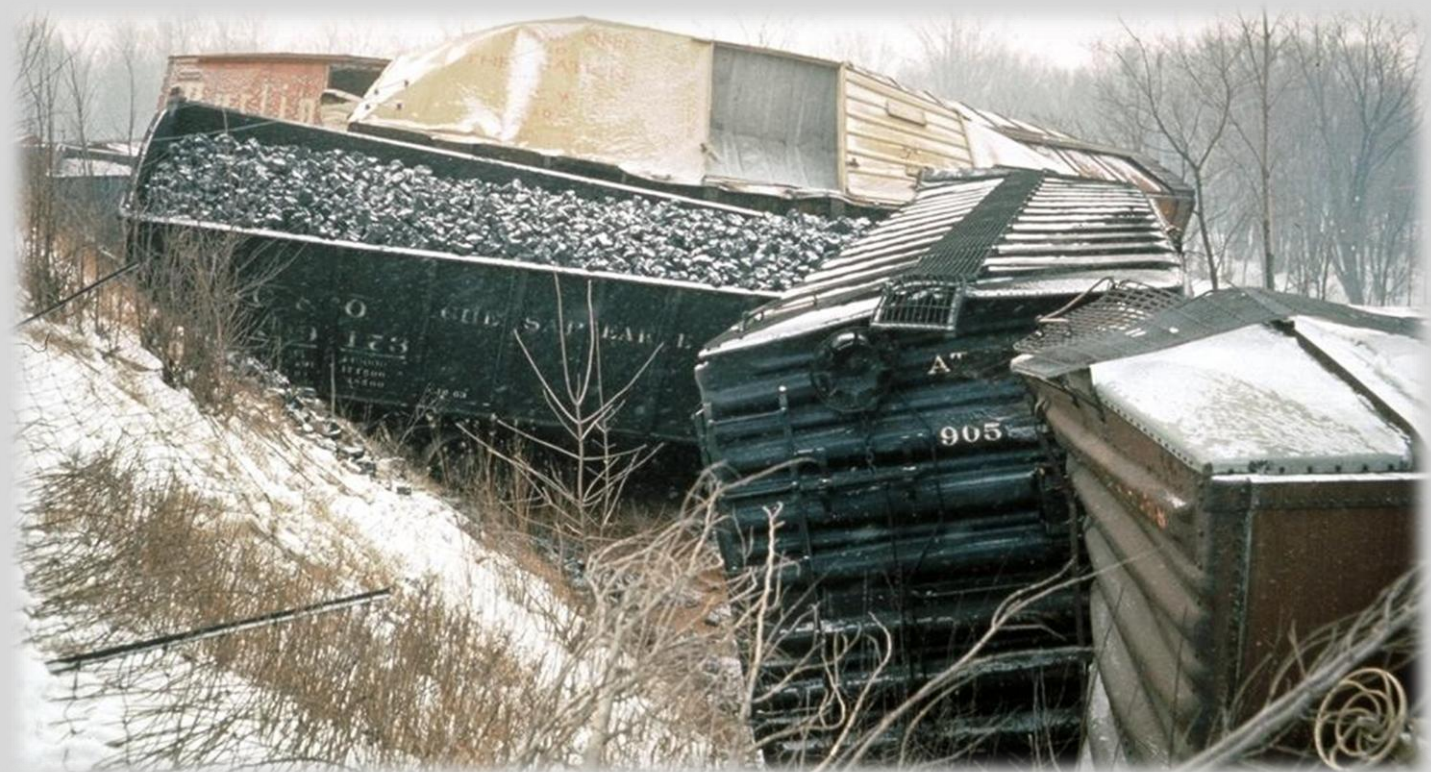
Above: Looking southeast are “dominoed” freight cars. The C&O hopper with coke for the Ford Motor Cleveland Foundry was a total loss. The Santa Fe box contained crude rubber destined New Jersey. The load was transferred. The car was home-shopped. Eighteen of 27 cars involved were destroyed. Jim Roberts’ photo, author’s collection.

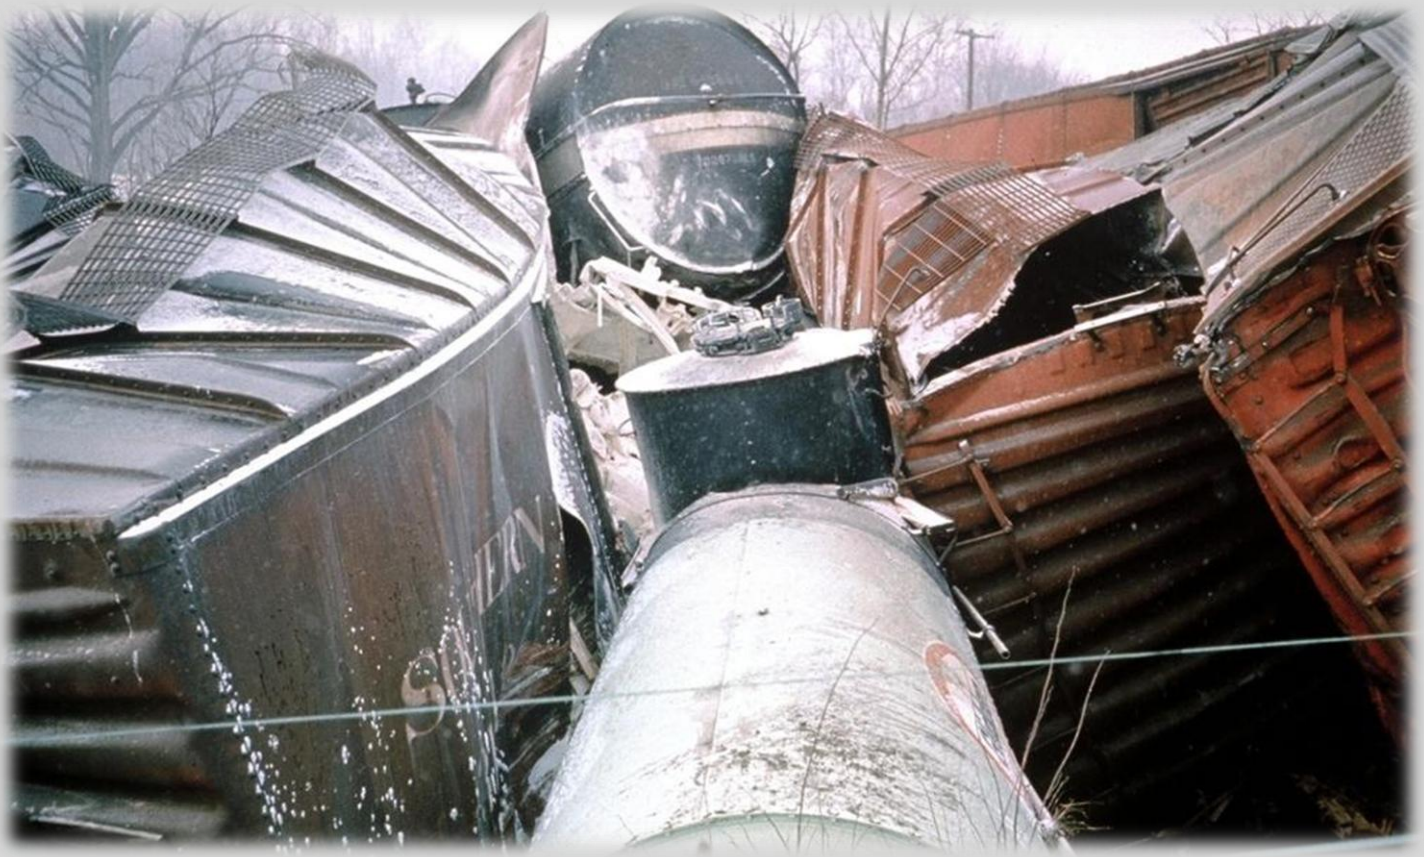
Above: Both GATX tank cars, the Glidden car in the foreground and the Goodyear tank behind were a total loss. The Southern box contained bagged clay destined Barberton. It was not repairable and was scrapped on site. Other boxcars are unidentified, but appear to have been casualties as well. Jim Roberts' photo, author's collection.

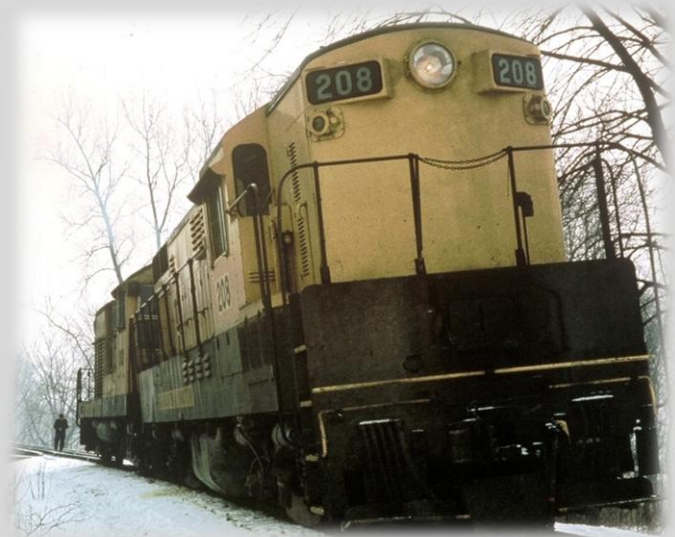
Above: Fortunately, AC&Y's F-M diesels Nos. 502-208 remained upright, though No. 208 was derailed. The mishap occurred near bridge 400, visible beyond the lead engine. Jim Roberts' photo, author's collection.

Only minimal damage arose to F-M diesels 502-208. Repairs totaled \$611.62. Sixteen freight claims were received amounting to \$28,299.42. The AC&Y absorbed \$500.00, the balance covered by insurance. No intended lading claims were received on five cars.

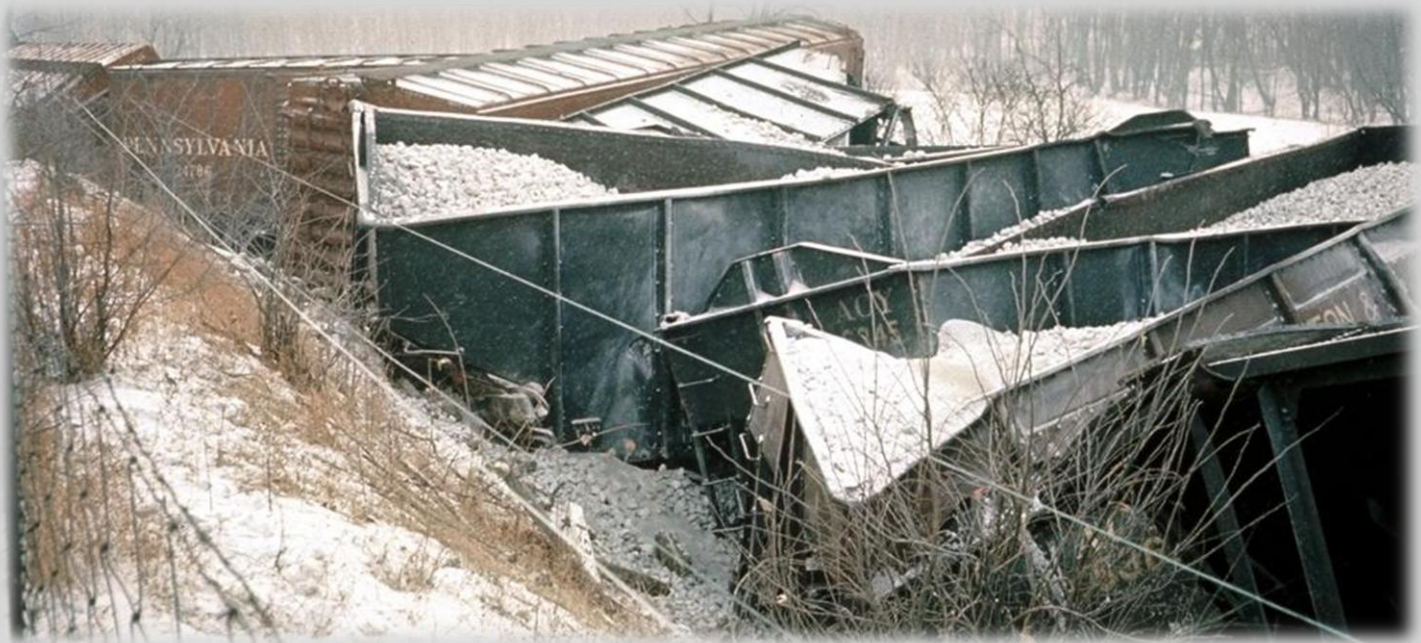
Above: Six AC&Y two-bay hoppers and one two-bay covered hopper, all loaded with crushed (fluxing) stone, were destroyed. The Pennsylvania box contained lumber destined New England. Temporarily repaired at Brittain, PRR 24786 was sent on to its destination and later rebuilt at the Altoona shops. Jim Roberts' photo, author's collection.

Four others cars, ACL 37783, PRR 24786 SP 173969 and GATX 63018 were eventually rebuilt by the owning roads, the repair costs billed to the AC&Y.

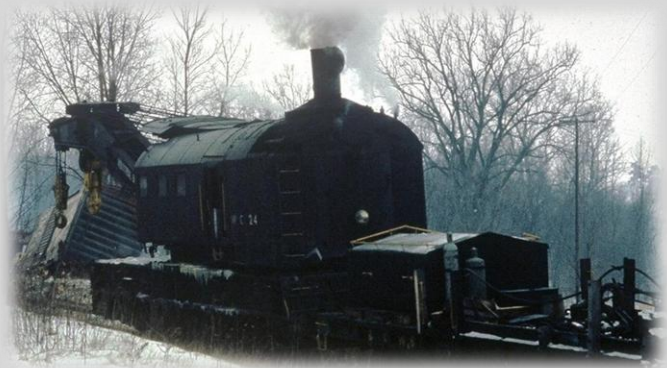
Above: AC&Y requested relief outfits from the C&O and N&W. C&O's 200-ton crane WC-24 and seven tool cars, based in Parsons (Columbus), worked four days to clear the wreck from the West, returning again in March. Jim Roberts photo, author's collection.

The C&O relief outfit deployed from Columbus, featured 200-ton wreck crane WC-24 and seven tool cars. Engaged from February 4–8, the C&O’s wreck train returned again March 16–19 to assist with cleanup. Wreck clearing expenses paid to N&W were \$2065.47 plus \$7433.53 and \$5120.50 to the C&O.

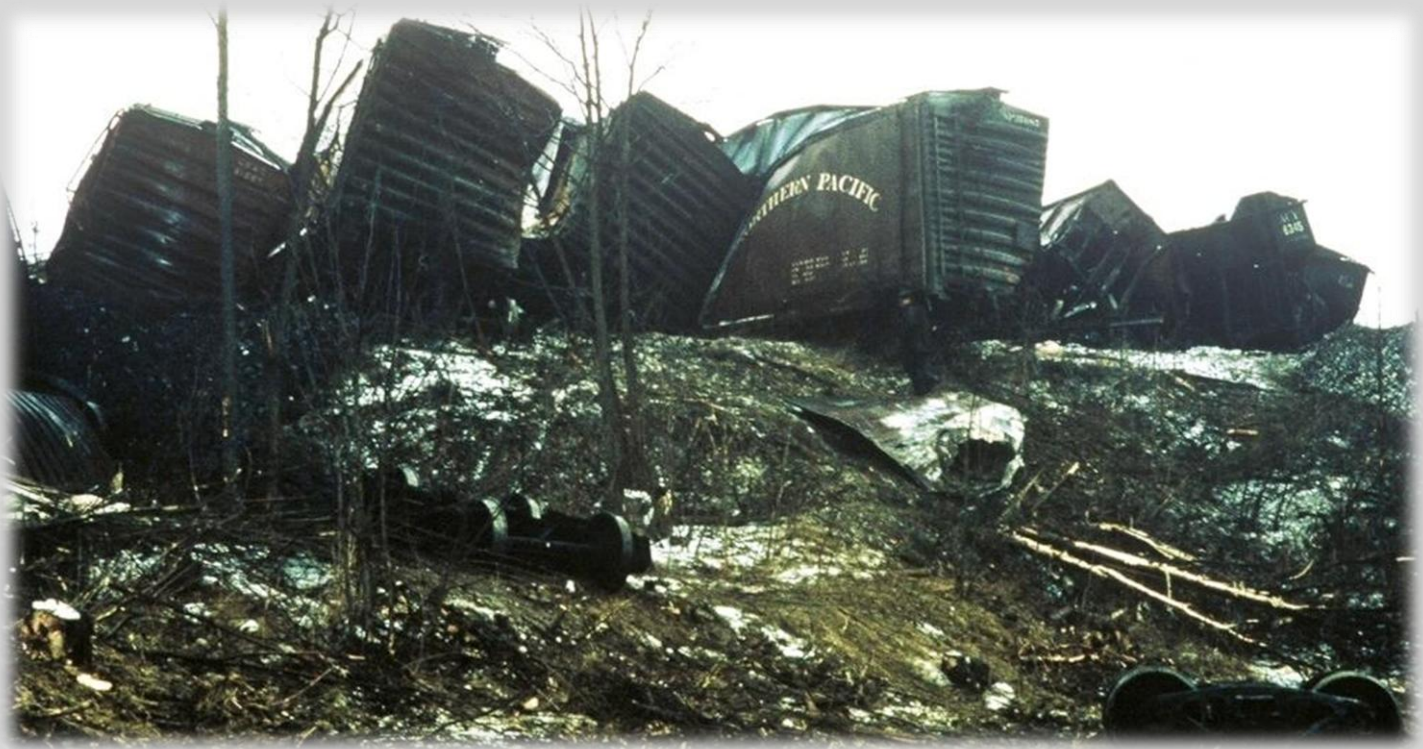
Above: The “accordion” of freight cars was a scene of utter devastation. Jim Roberts’ photo, author’s collection.

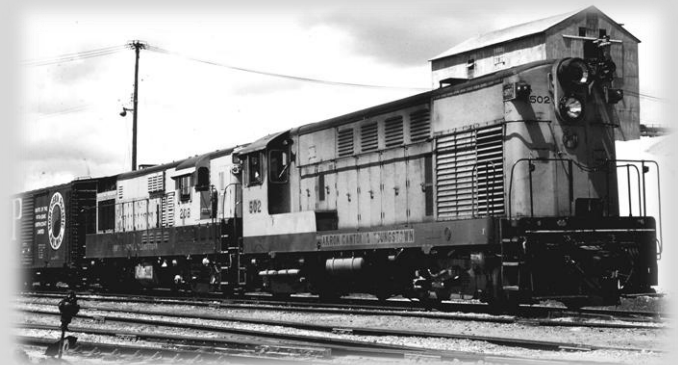
Above: F-M units 502-208 paired at Carey in 1963. No. 502 was involved in no less than six derailments between 1964 and 1967. Author’s Collection.

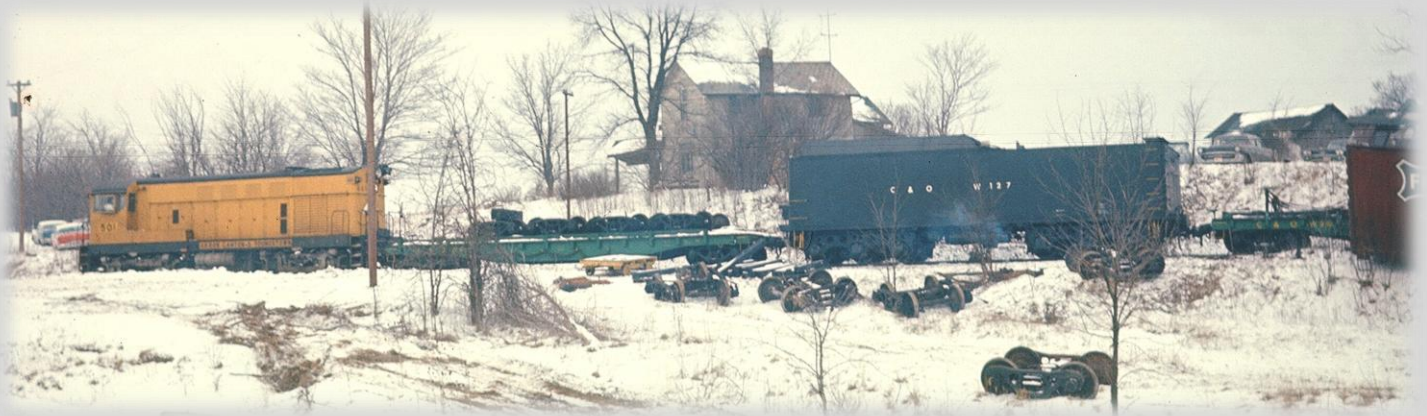
Above: On February 4, 1966, the AC&Y endured a major train derailment at Tymochtee, east of Carey. A relief wreck crew is working the west end of the derailment. Jim Robert's photo, Author's collection.

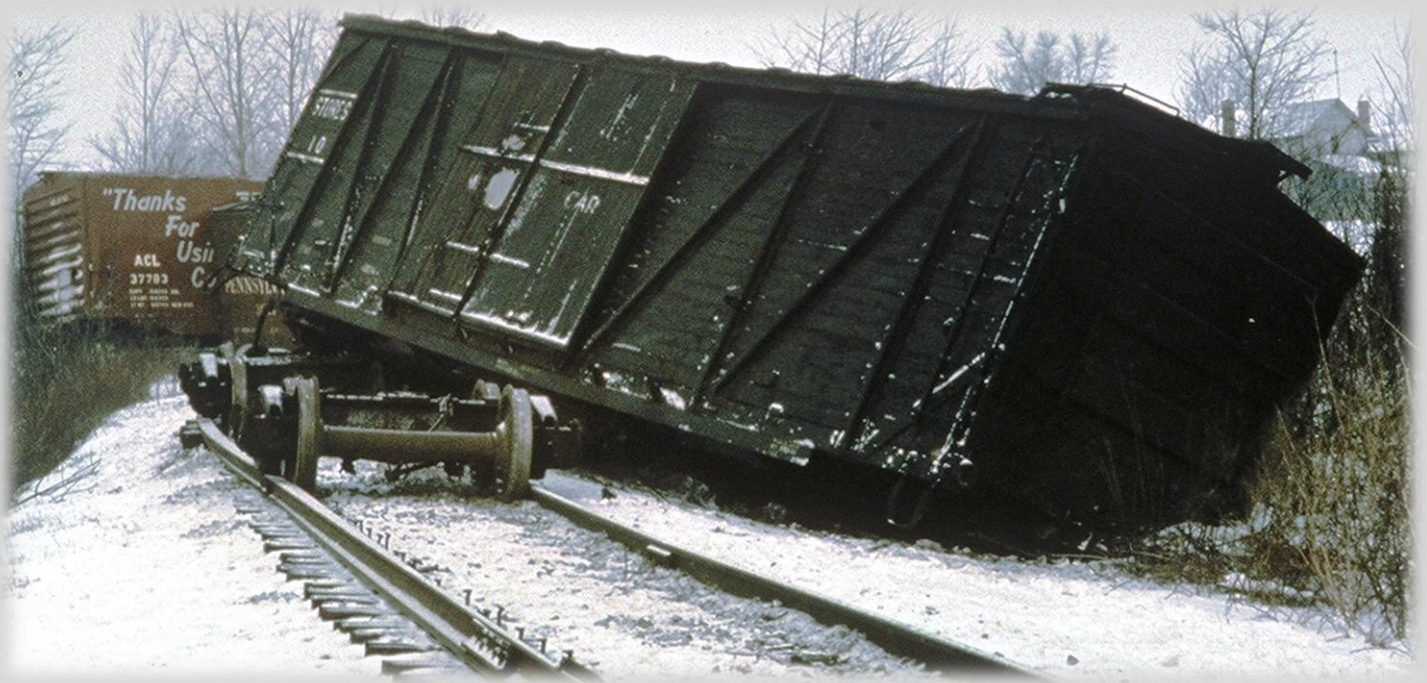
Above: AC&Y's non-revenue Stores No. 10, a former Piedmont & Northern boxcar acquired second-hand in 1939, was returning to Brittain yard on Train 94 with company material. It was the last car derailed. Stores No. 10 was previously AC&Y revenue boxcar No. 2015, assigned to the Stores Department in 1955. Relatively undamaged, the decision was made to scrap Stores No. 10, then forty-one years old. Jim Roberts' photo, author's collection.

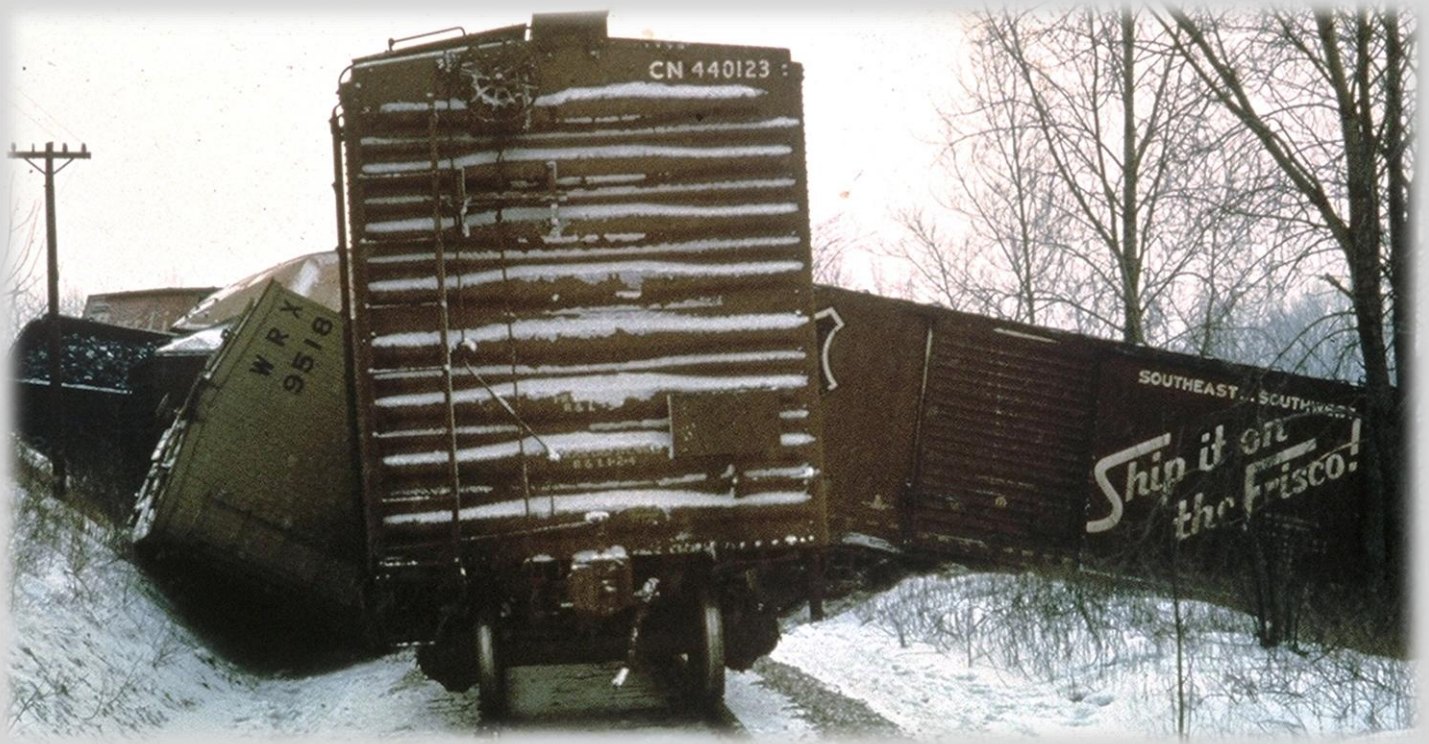
Above: Nearly all of the freight cars involved in the derailment were Post-War modern steel construction. Yet, one vintage car appears behind the CN box. WRX No. 9518, a 40-ton ice-bunker refrigerator, was one of a small number of cars owned by the Western Refrigerator Line for the Green Bay & Western Railroad. This car was built between 1932 and 1936. Jim Roberts' photo, author's collection.

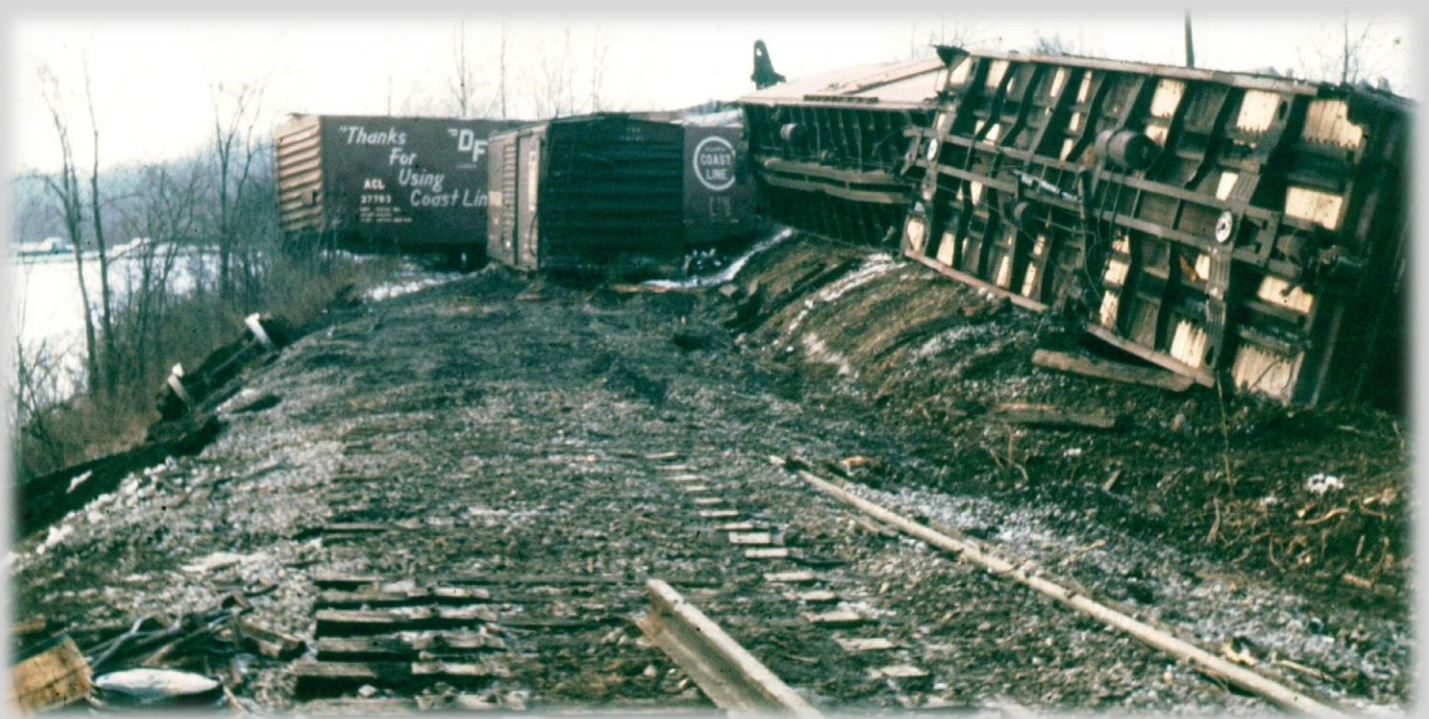
Above: Another later view of the 1966 Tymochtee derailment shows the right-of-way. The track was likely removed to allow bull dozers to clear damaged equipment so the line could be reopened. Note the new wood floor showing on the overturned boxcar to the right. Jim Robert' photo, author's collection.

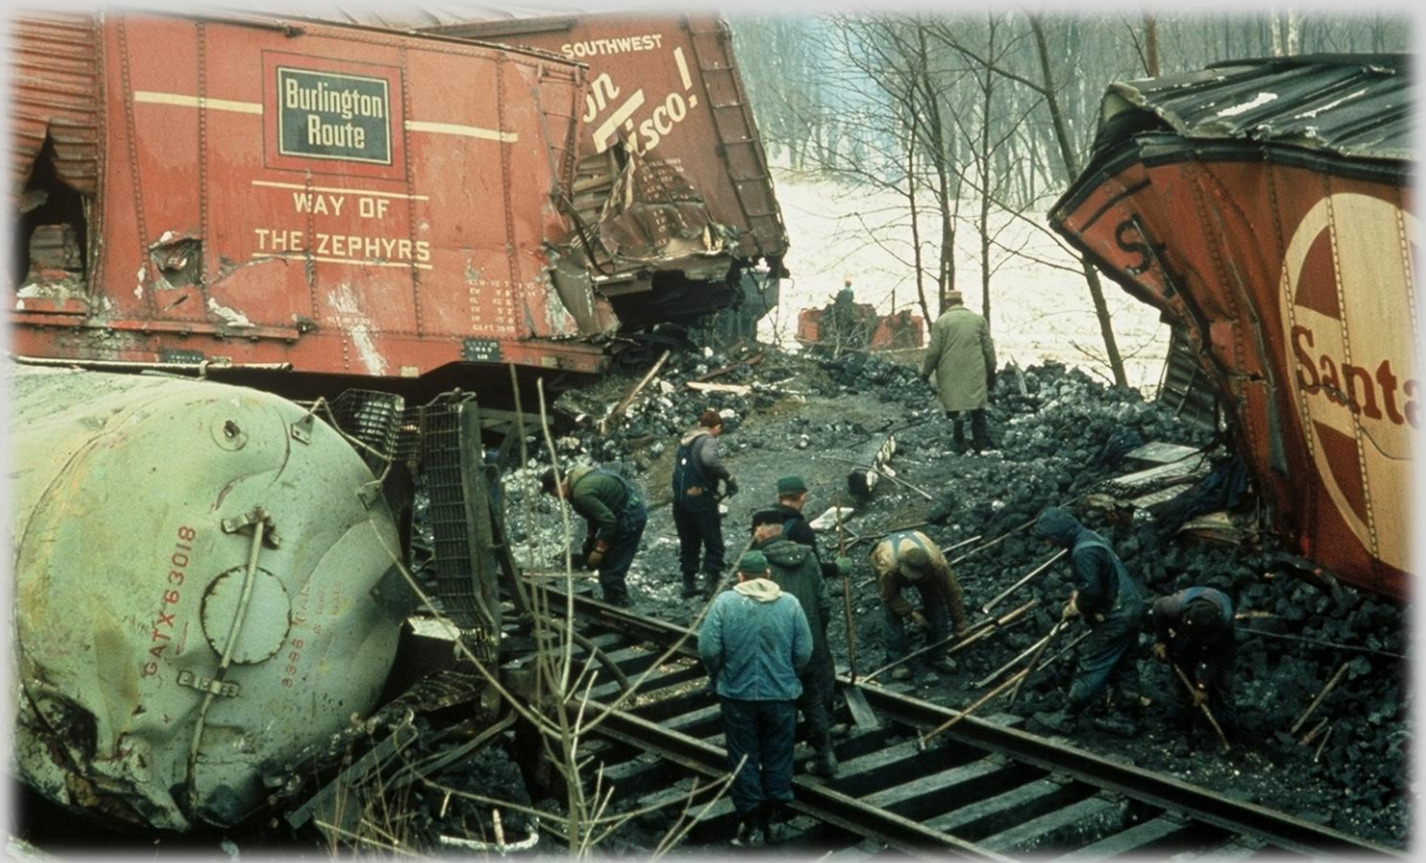
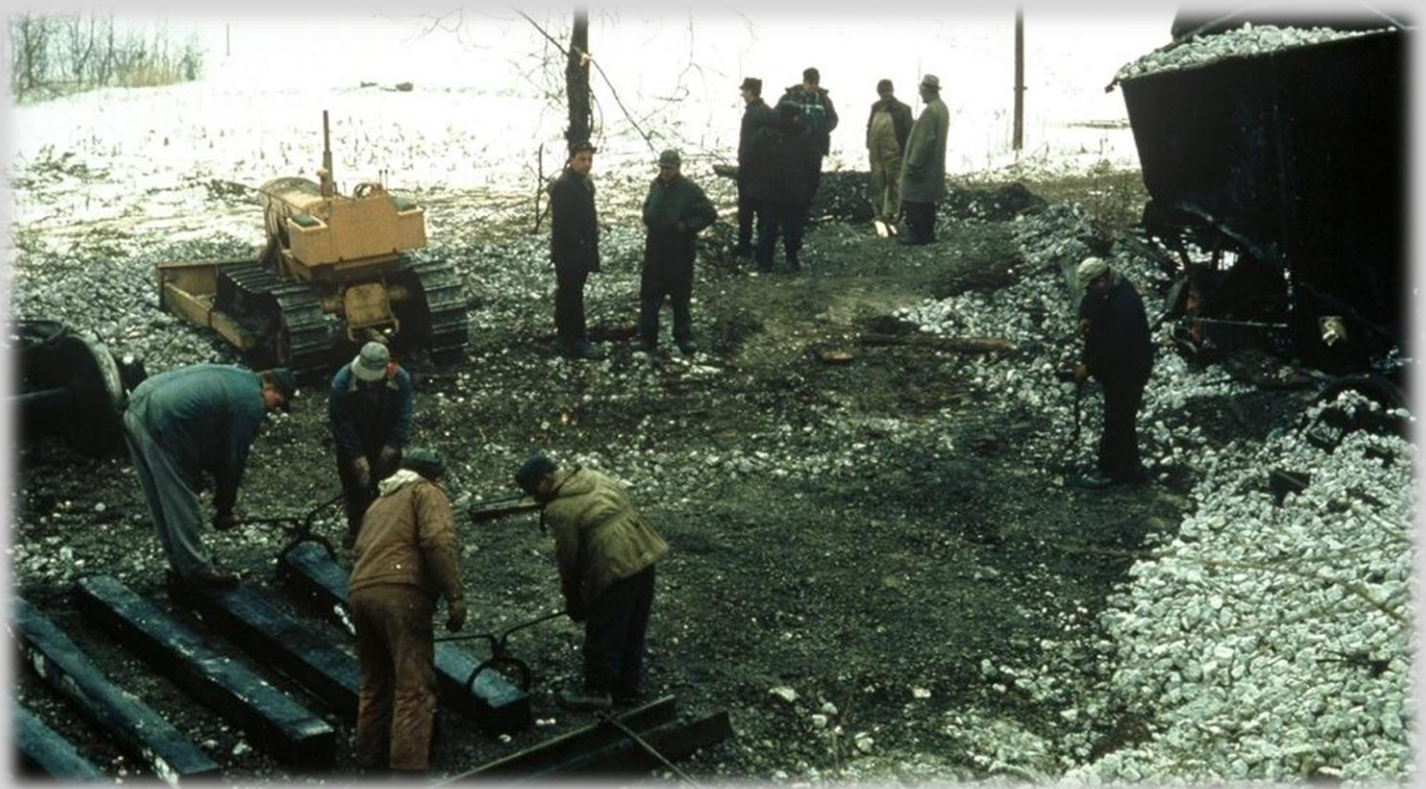
Above: Section hands and relief crews had a busy few days restoring the AC&Y main line to service. There appears to be no shortage of supervisory help. Jim Roberts' photo, author's collection.

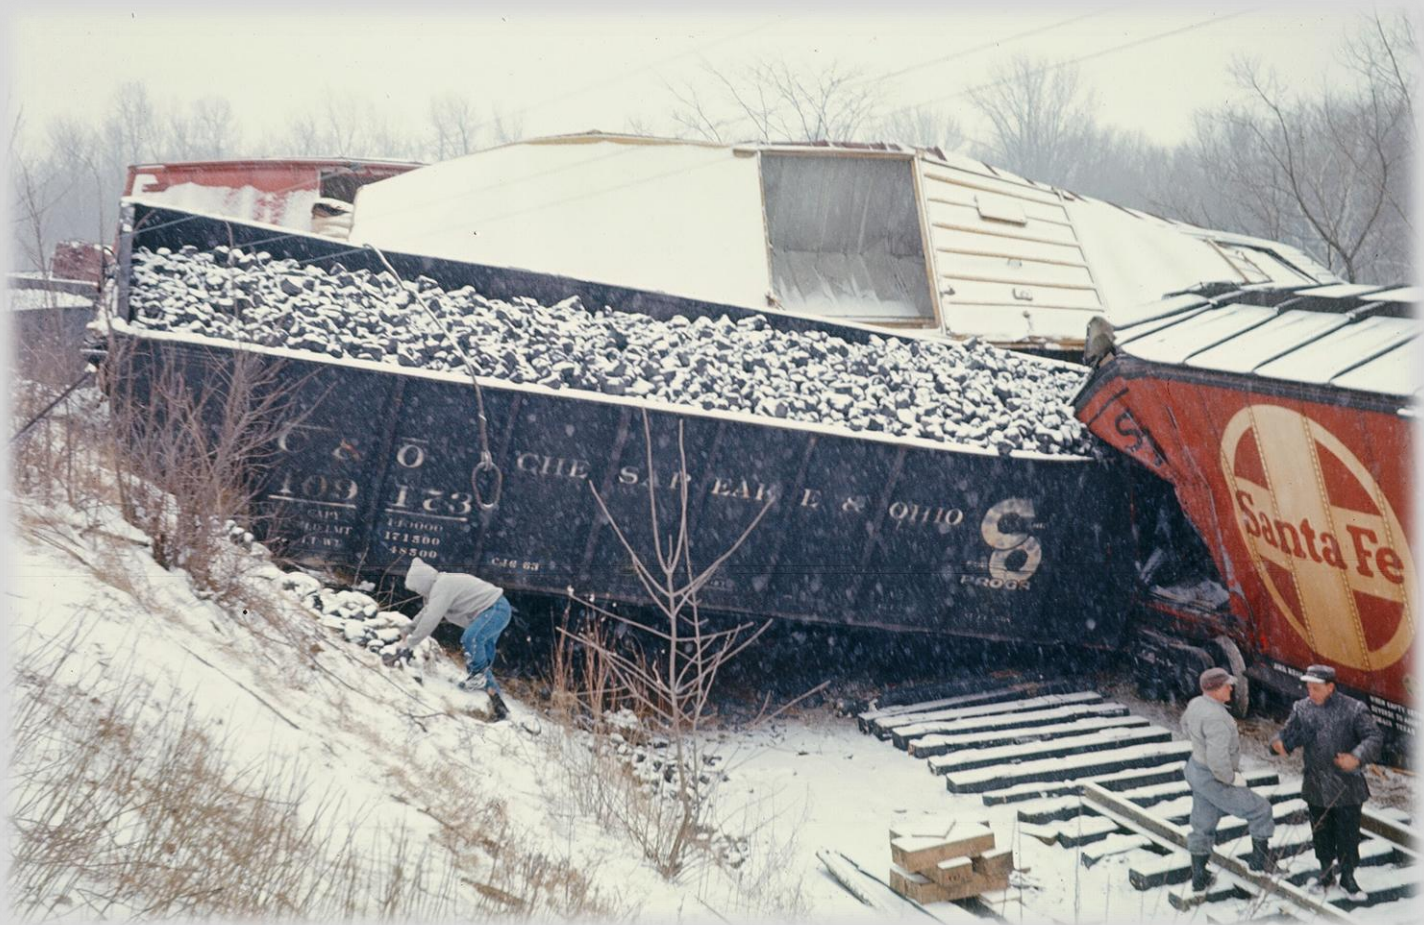
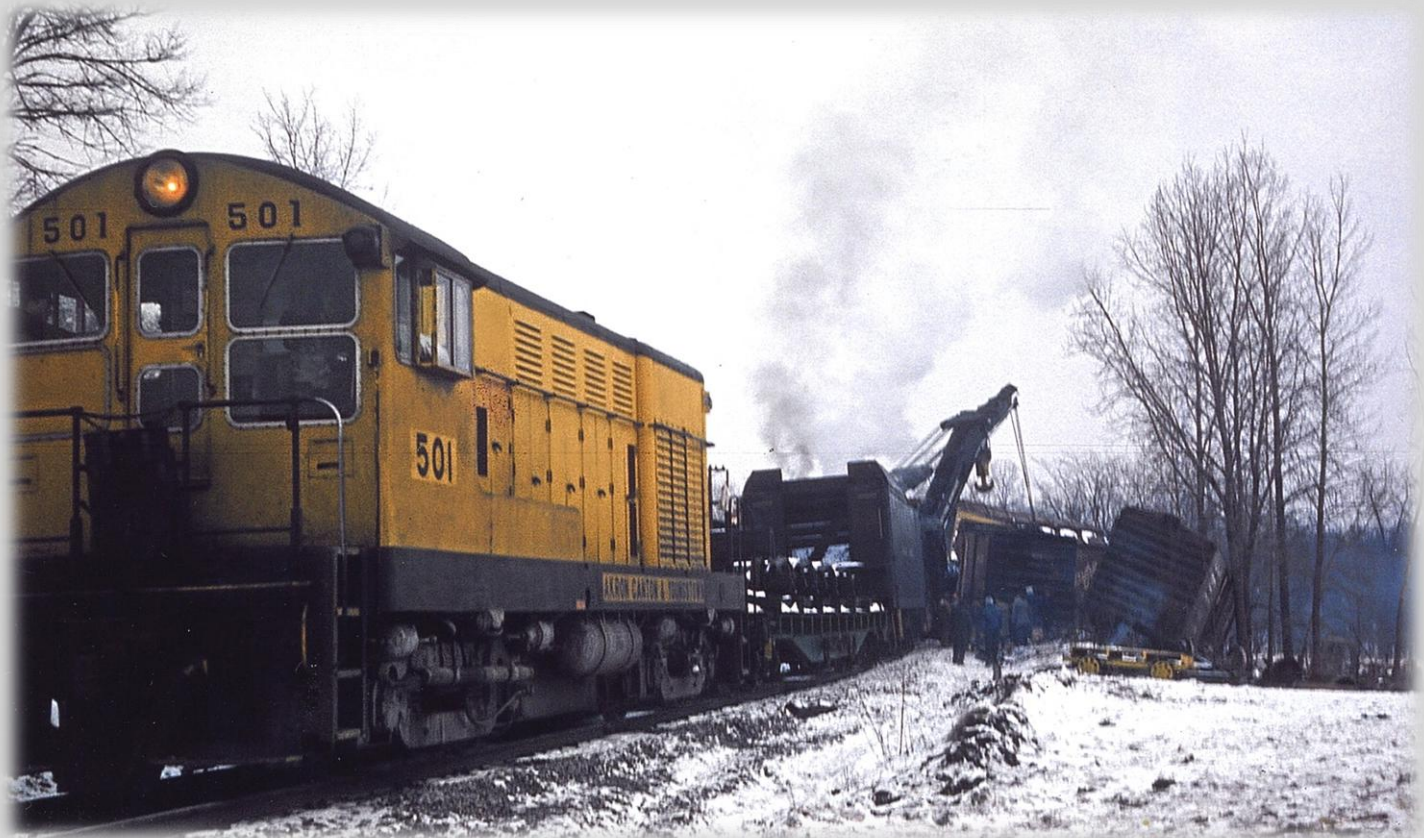
Above: The C&O hopper with coke for the Ford Cleveland Engine plant was scrapped on site. F-M 501 is working the west end of the derailment with a C&O relief outfit from Columbus. Jim Semon collection.
